# Manhole Inspection Summary

Manhole # S47G\_\_004MH

Insp Date: **5/1/08 10:20 AM**

**Location** Address: **2125 Pratt Gough**

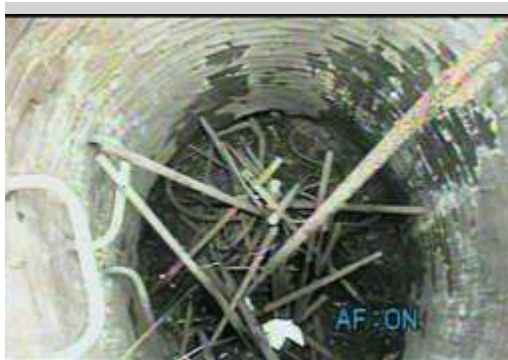
Defect 3

Condition: ☐ Sound ☐ Cracked ☐ Root Intrusion ☐ Deteriorated ☐ Leaks ☒ **Debris**

channel debris

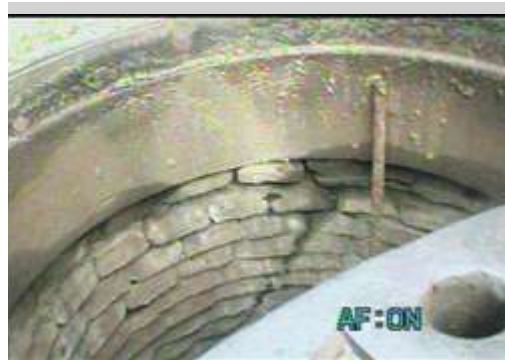
Defect 1

Condition: ☐ Sound ☐ Cracked ☐ Root Intrusion ☒ **Loose Brick** ☒ **Deteriorated**

Infiltration: ☐ None ☒ **Joint** ☐ Cracks ☐ Mortar ☐ Roots ☐ Wall

Condition: ☐ Sound ☒ **Cracked** ☐ Root Intrusion ☐ Loose Brick ☐ Deteriorated

Infiltration: ☐ None ☐ Joint ☒ **Cracks** ☐ Mortar ☐ Roots ☐ Wall

chimney is deteriorated with loose bricks and infiltration from joint, corbel is cracked with flow from crack

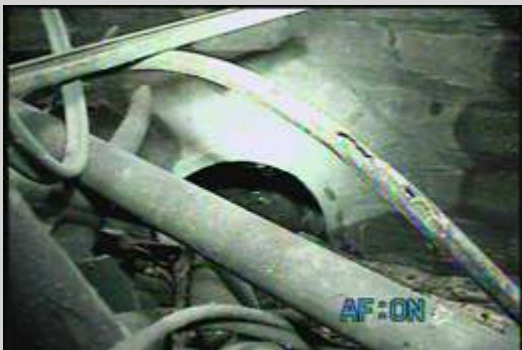
12 O'Clock Outflow

8 in. Circular Gravity Sewer  
Pipe Out @ 12 O'Clock

Deposits: ☐ None ☐ Mud ☐ Sludge ☒ **Debris** ☐ Grease

Silt Depth: 3 (in.) Deposits Extent: **Medium**
